# Kawa Stream Bioassessment

**Susan Burr**  
**Environmental Planning Office**  
**Hawaii Department of Health**  
**February 2001**

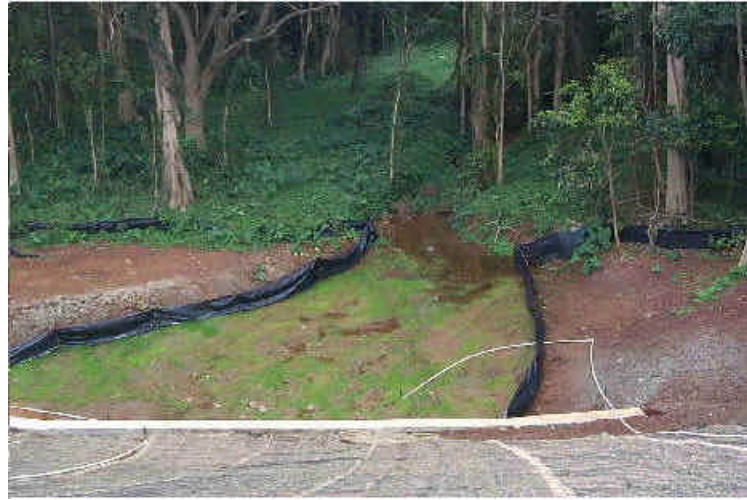
**Figure 2. Upper East Branch.**

Numerous small branches of Kawa Stream, some of which originate as springs, arise in or near the Hawaiian Memorial Cemetery and National Veteran's Cemetery. The headwaters of the central branch have been buried beneath the cemetery lawn. Grated drains collect sheet flow from the lawns and transfer the water to pipe culverts where it joins the stream in an open concrete box culvert that leads to a pool held back by channel-clogging California grass (*Brachiaria mutica*). The upper east branch drains a forested area east of the cemetery (Figure 2) and the upper west branch arises in a swale behind the cemetery base yard.

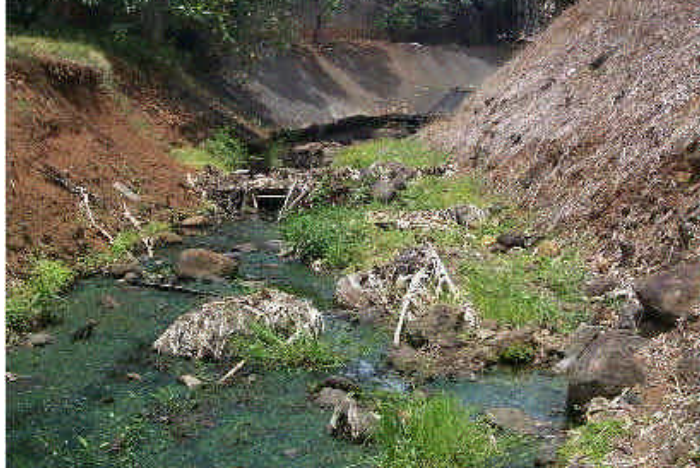
**Figure 4. Lower Middle Reach.**

Land use along the Lower Middle Reach is primarily residential. The reach is composed mostly of long shallow pools separated by riffle zones or artificial drops. Substantial bed erosion is occurring in the Lower Middle Reach; the left banks are steep and bare with weedy terraces and the right banks are mostly lined with concrete as they pass next to a row of houses (Figure 4). The bottom of the Lower Middle

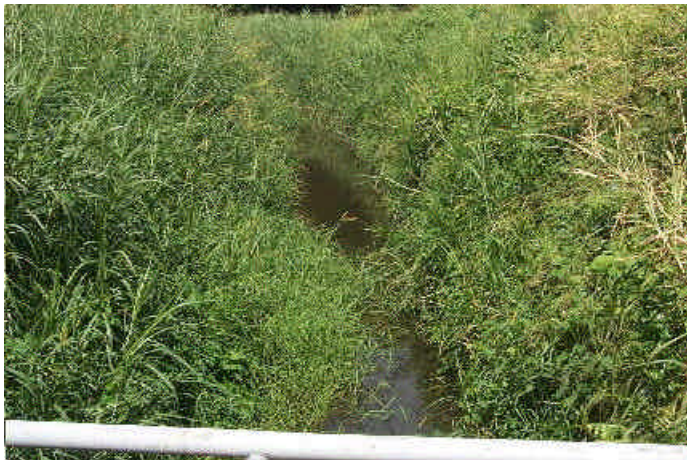
**Figure 5. Lower Reach.**

The Lower Reach begins in a large pool with a soft sediment bottom below a basalt outcrop then flows through a channel choked with elephant grass (*Pennisetum purpureum*). Through the golf course and the wastewater treatment plant property, the stream is confined to an artificial unlined channel (Figure 5). The stream flows next to a fish pond, the old Waikalua-Loko, where it is lined with red mangrove (*Rhizophora mangle*), and finally enters Kaneohe Bay beside the fish pond.

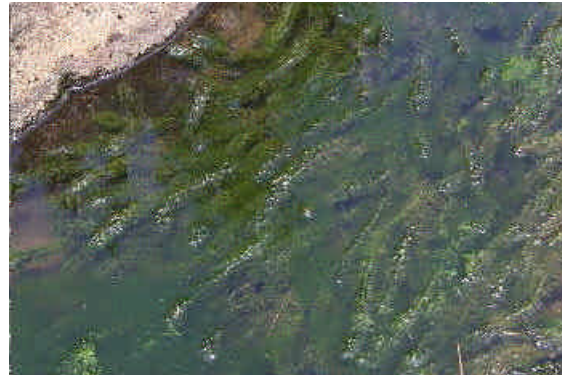
**Figure 6. Aquatic Plants at Station #12.**

Lower Middle Reach. Located below Castle High School, runs under Kaneohe Bay Drive, and ends in a hau thicket just above an old gaging station, which is currently being used by HDOH contractors (Oceanit) to measure streamflow. The majority of the stream bank has been hardened or is denuded and eroding as a result of over-application of herbicide. Station #12 has a fair amount of habitat heterogeneity, with riffles with exposed bedrock dominating over short runs and small pools. A large number of non-native aquatic plants were growing in the stream at the time of the surveys (Figure 6). Introduced fishes dominate the fauna, although we found one native goby during our surveys.

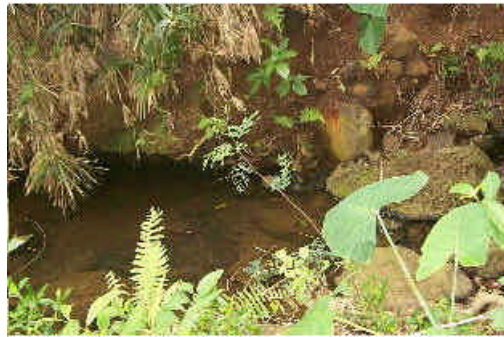
**Figure 7. Station #8.**

The three habitat characteristics for which Station #8 scored the lowest relative to other Kawa Stream sites are all inter-related: lack of understory, unstable banks, and high substrate embeddedness. While this is the only sizable section of Kawa Stream that remains relatively undeveloped (leading to good scores for lack of channel alteration and adequate riparian zone width) (Figure 7), human activity has so altered the stream that it no longer provides suitable habitat for native macrofauna. The surrounding landscape is dominated by mango and cinnamon trees, leaving significant amounts exposed earth beneath the trees. The lack of vegetation leads to unstable banks and as a result, the natural stream substrate is buried and the optimal heterogeneous habitat structure is eliminated.

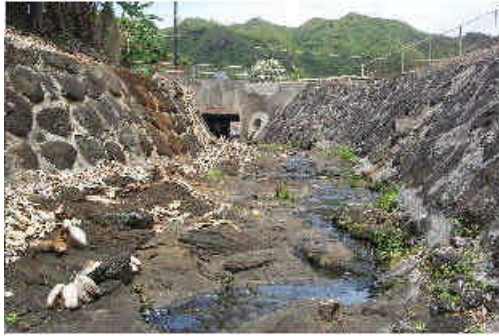
Station #6 scored the lowest in terms of habitat for the sites monitored in Kawa Stream. This small tributary running through the heart of the residential district has been heavily modified by humans (Figure 8). The channel has been straightened, deepened, and lined with concrete, and as a result, the sediment load has increased

and the velocity-depth combinations that create habitat heterogeneity necessary for native macrofauna are nearly absent. Development of the surrounding residential area has eliminated the riparian zone and the concrete-lined banks or bare slopes and cleared access road have all but eliminated the understory.

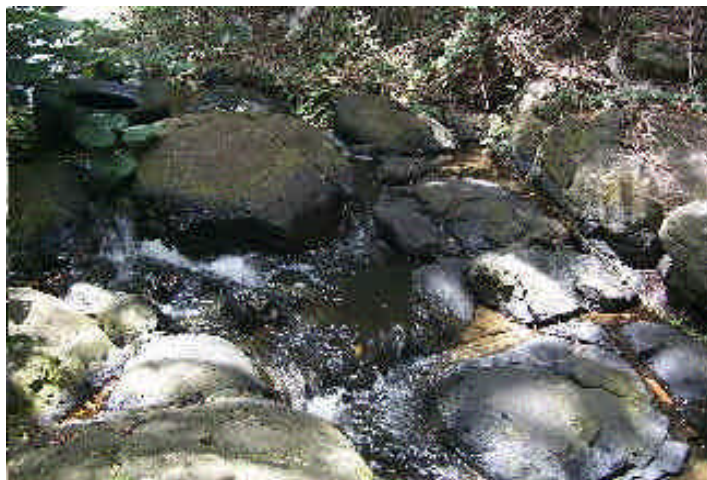
**Figure 9. Station #12.**

Station #12 is similar to the other Lower Middle Reach station, #6, although the channel width is larger, the bedrock bottom provides more habitat heterogeneity (Figure 9), and the site has the expected amount of velocity-depth combinations for its slope. However, the majority of the stream banks are lined with concrete or are bare soil that is sprayed with herbicide on a regular basis. There is virtually no understory, and only the lower section of the site has a vegetated riparian zone

(although it is dominated by hau). The ratio of wetted stream width to the ordinary high water mark is low at Station #6, resulting in a loss of habitat for native macrofauna and probably also elevated temperatures.

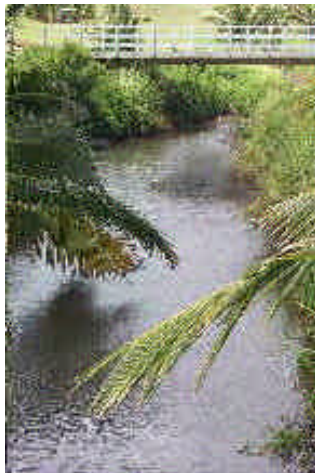
**Figure 10. Station #5.**

Station #5 has characteristics expected of a modified channel flowing through a golf course (Figure 10). Efforts to straighten and deepen the channel have greatly reduced habitat availability and the riparian zone has been virtually eliminated for most of the site. All stations monitored at Kawa Stream scored a zero for presence of native vegetation, including Station #5. Only one or two individual specimens of native plants or Polynesian introductions were found at each site.

Although some sections of the bank were eroding, overall, the banks were fairly stable and vegetated with an understory dominated by introduced vines and grasses.

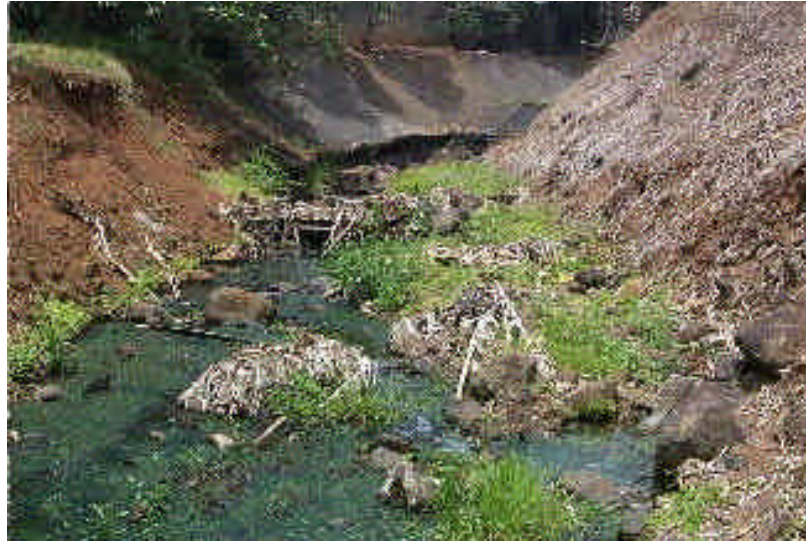
A eutrophic stream is not likely to be capable of supporting the designated uses listed in the water quality standards. As set forth in HAR §11-54-03(b)(2), the uses to be protected in Kawa Stream, a Class 2 water, encompass “all uses compatible with the protection and propagation of fish, shellfish, and wildlife, and with recreation in and on these waters.” A eutrophic stream does not provide supporting habitat for native fish and is not conducive to recreation (Figure 12).

***Figure 12. Eutrophic section of Kawa Stream.***

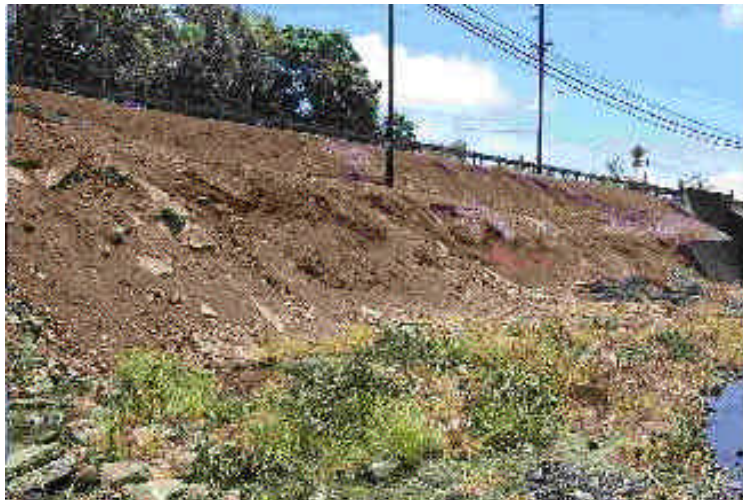
***Figure 13. Denuded Stream Banks near Castle High School.***

We recommend that revegetation efforts take place at every section of stream that is not hardened. The City and County of Honolulu maintenance crews who denude the stream banks near Castle High School with over-application of herbicides should be asked to evaluate their maintenance goals and attempt to find alternative methods to achieve their intended goal (Figure 13). The student population of Castle High School is likely willing to assist in restoration efforts next to their school. The section of Kawa Stream running through the golf course should meet the management goals. The riparian zone should be expanded to meet the minimum requirements to support good water quality. The riparian zone should be planted with native vegetation and an adequate understory should be established. The golf course should also adequately stabilize the sections of the bank that are severely eroding.
